Presskonferens i Tallinn 251216

# **Final Report of Preliminary Assessment of New Findings on M/V ESTONIA Accident**

## Översikt av den preliminära bedömningen av förlisningen av M/V ESTONIA

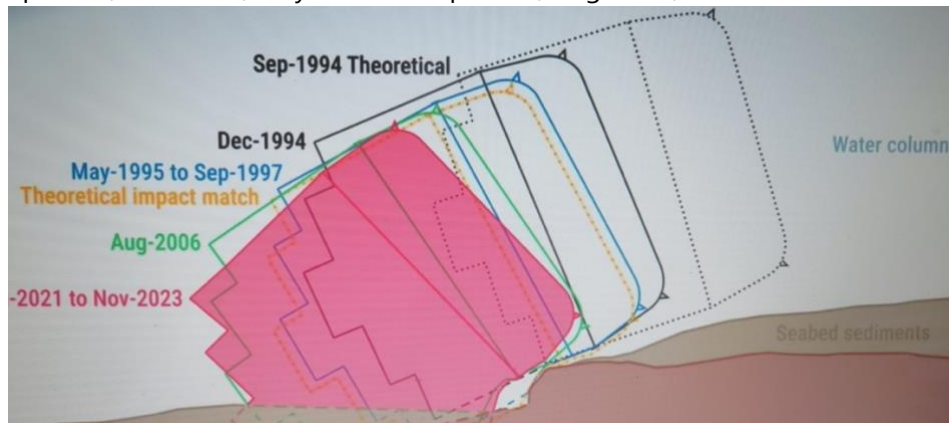
FIG. 0.2: A sectional cut at midships, near the forward penetrating damage, illustrates the wreck's movement over the decades.

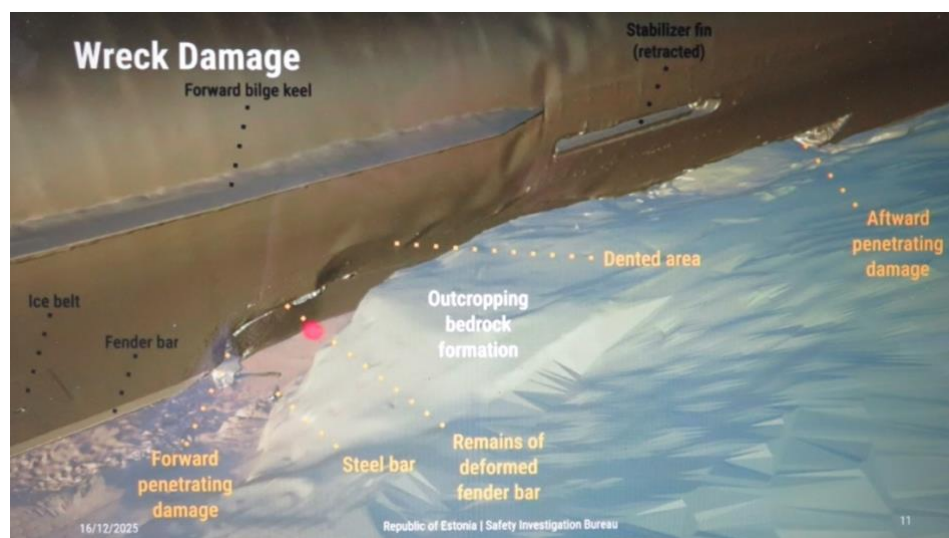
FIG. 3.34: Wreck side damage and the corresponding seabed on the digital model.

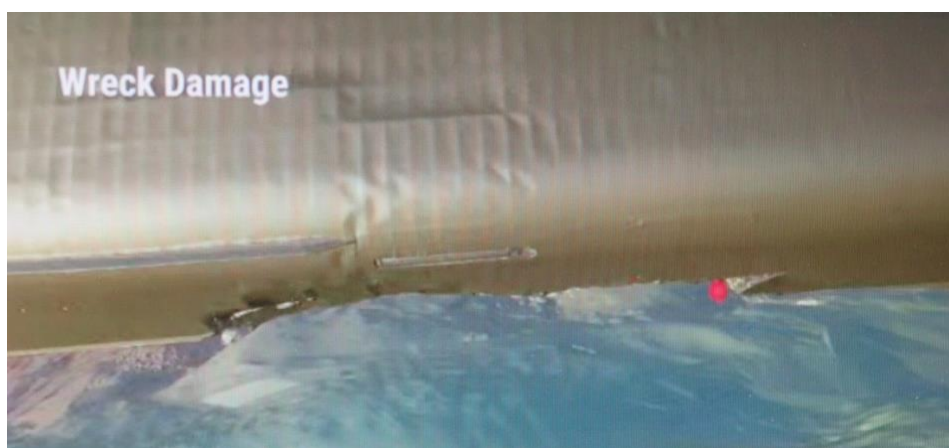
FIG. 3.35: Wreck side damage and the corresponding seabed on the digital model, side view.

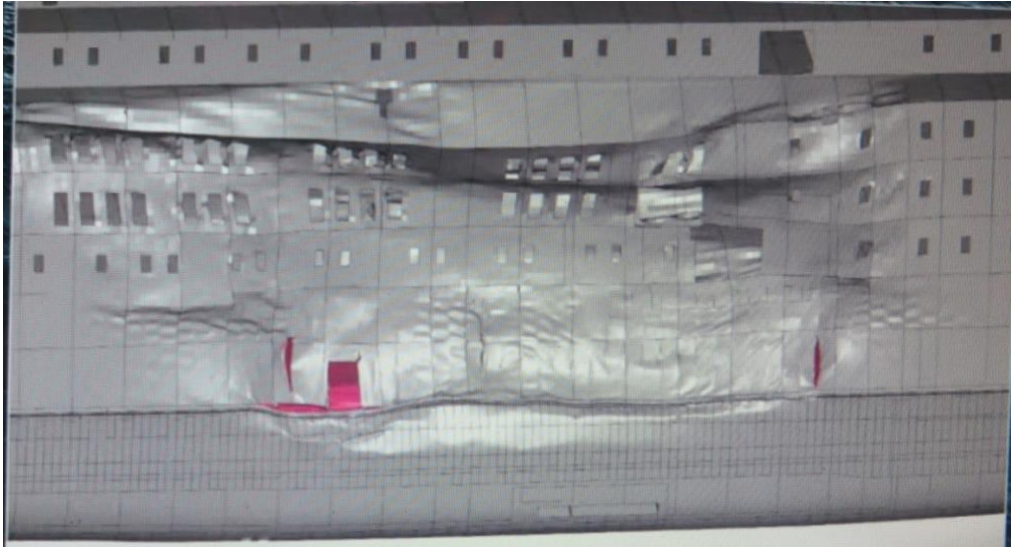
FIG. 3.42: Wreck deformations on theoretical FEM model after bottom contact with the bedrock. Damage stemming from direct impact with the bedrock under wreck's own weight is illustrated. However, the full descent was not simulated and the full extent of deformations were not included. 'Brown' is the bedrock; 'Pink' illustrates penetrating damage. Source: Tabri and Heinvee

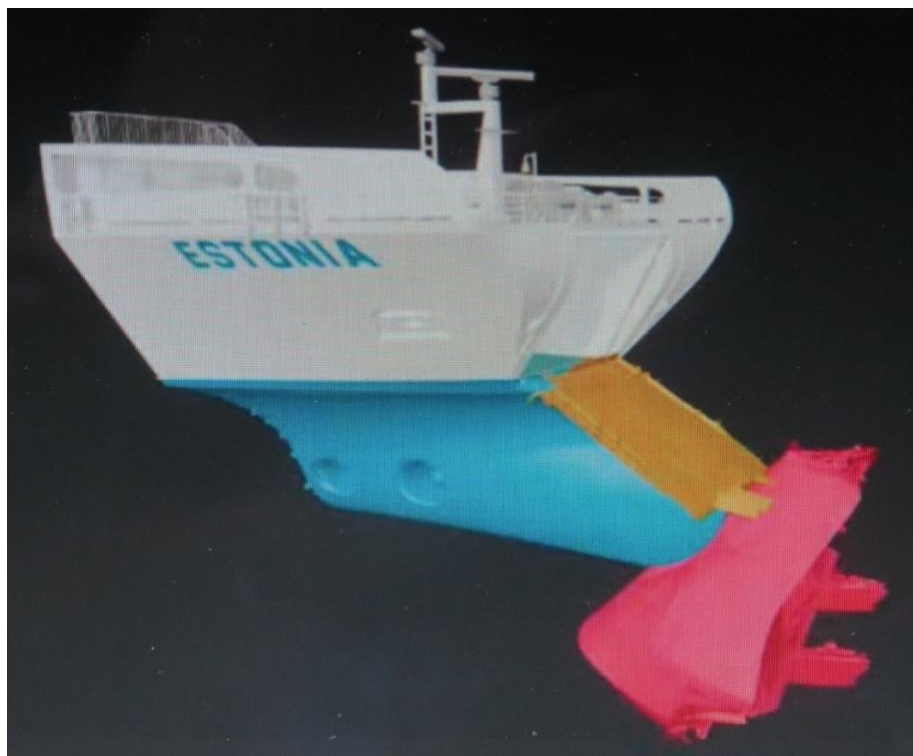
FIG. 4.5: Physical damage of the bow visor and the ramp confirming the full opening of the vessel's bow entrance at the beginning of the accident. The large dent in the front side of the visor (red) is aligned with the bulbous bow and the ramp's (yellow) underside deformations are aligned with the forepeak deck. Visor actuators are not shown.

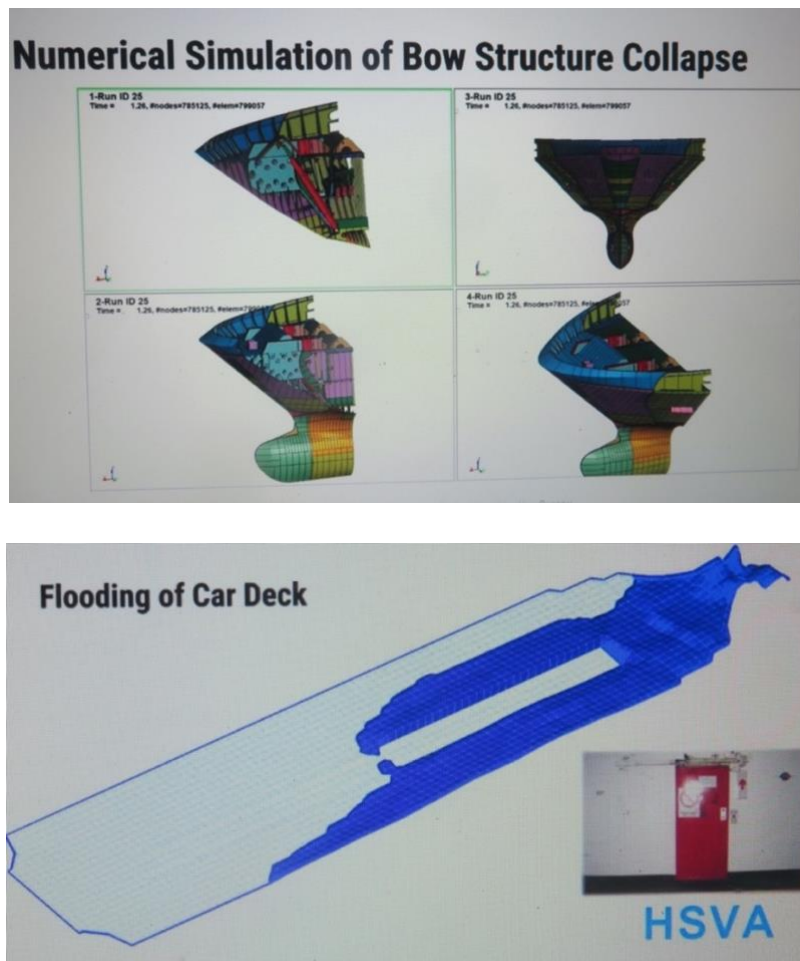
FIG. 4.6: Visualization of the numerical flooding process in the HSVA-Rolls program, illustrating the flooding of the car deck from ahead seas: sloshing water is divided by the centre casing (visible walls not included). Accumulation of water to the port side of the centre casing creates water pressure to non-watertight sliding doors (fire doors). Source: Kim et al.

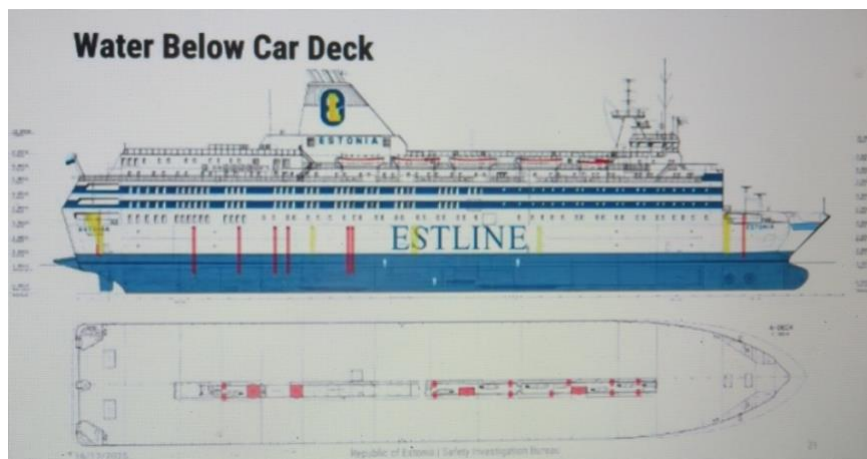
FIG. 4.8: Lowest ventilation openings on the starboard side of the vessel opening to outer shell. 'Red' indicates ventilation channels running below the car deck and 'Yellow' to the car deck. Ventilation channels on other side of the vessel and openings only inside are not shown. Non-weathertight sliding fire doors and elevator doors on the first level of car deck in 'Red'. Other doors and hatches on the car deck are not highlighted.

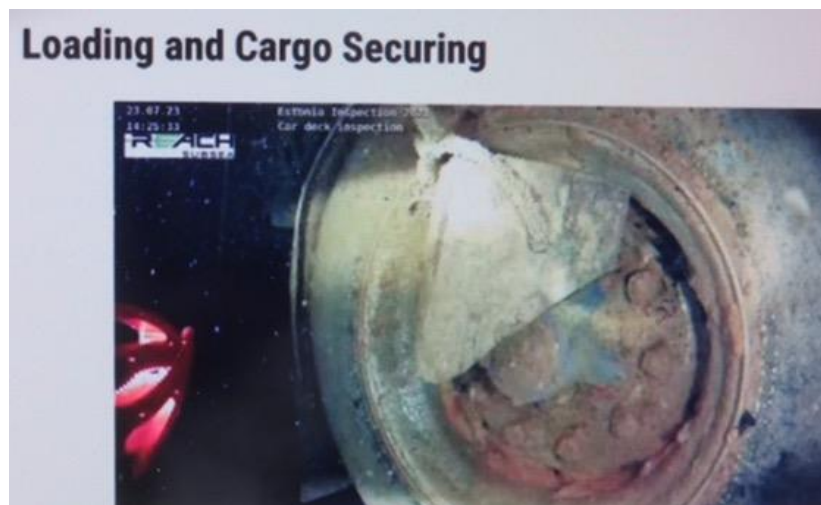
FIG. 5.3: Footage from the car deck shows a cargo securing chock next to the shifted cargo unit on the car deck of MV ESTONIA during the visual inspection in 2023 (O 2.21).

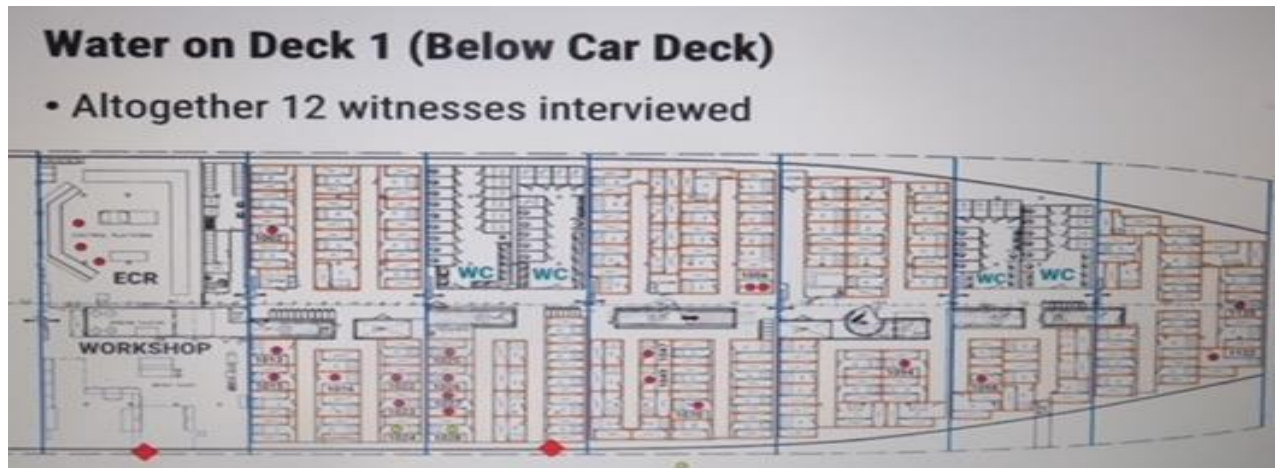
FIG. 5.5: Extract from Deck 1 drawing. The red dots show location of the survivors as highlighted in the JAIC [Final Report](#). [3, p. 68] The yellow dots show location of those not indicated by JAIC (the one outside cannot be connected to a certain cabin). All survivors on the image have not been interviewed 2021 – 2024, thus may not be mentioned in the text. Altogether, at least 25 survivors evacuated from Deck 1. The starboard side forward and aftward penetrating damage is marked by red rhombs.
