Presskonferens i Tallinn 251216

# **Final Report of Preliminary Assessment of New Findings on M/V ESTONIA Accident**

## Översikt av den preliminära bedömningen av förlisningen av M/V ESTONIA

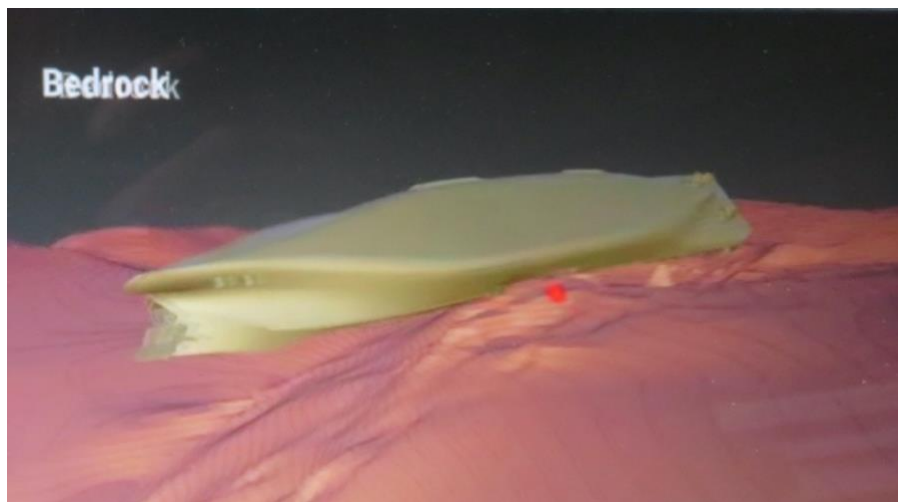
FIG. 3.4: Reconstructed top bedrock surface with a partial model of the wreck. The bedrock surface is based on the 2024 reconstruction.[47] The layers between the seabed and the bedrock are not shown. The wreck is shown primarily as measured during the photogrammetry survey (O 2.20); as the photogrammetry did not image below the seabed layer (not shown here), the parts of the wreck currently extending below the seabed are not shown.

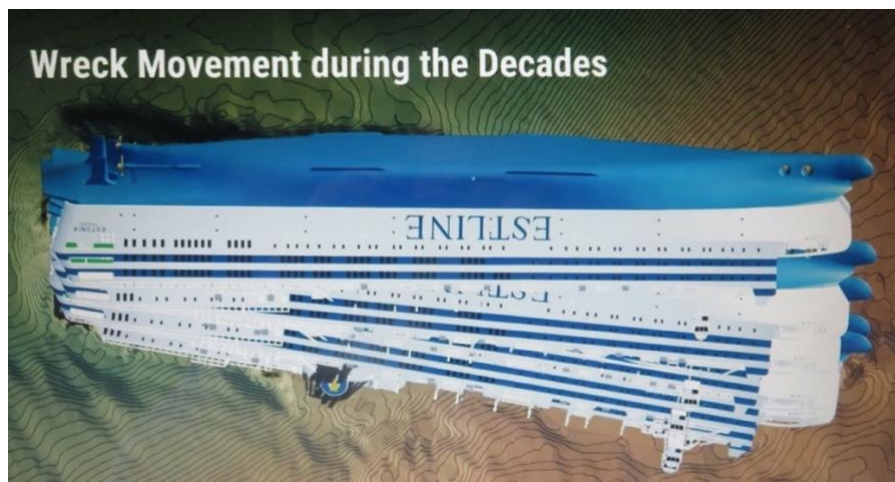
FIG. 3.26: Top view of the five reconstructed positions of the wreck from 1994 to 2023

(Sep-1994, Dec-1994, May-1995 to Sep-1997, Aug-2000, Jul-2021 to Nov-2023)

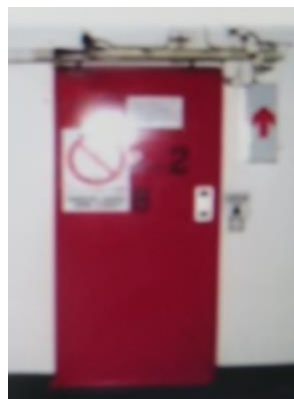
FIG. 4.7: Sliding fire door on the car deck of MV MARE BALTICUM, the near-sistership of MV ESTONIA. Source: Börje Stenström, 1995-11-07, SHK Archives, F 1 HB. 23A B15.6.

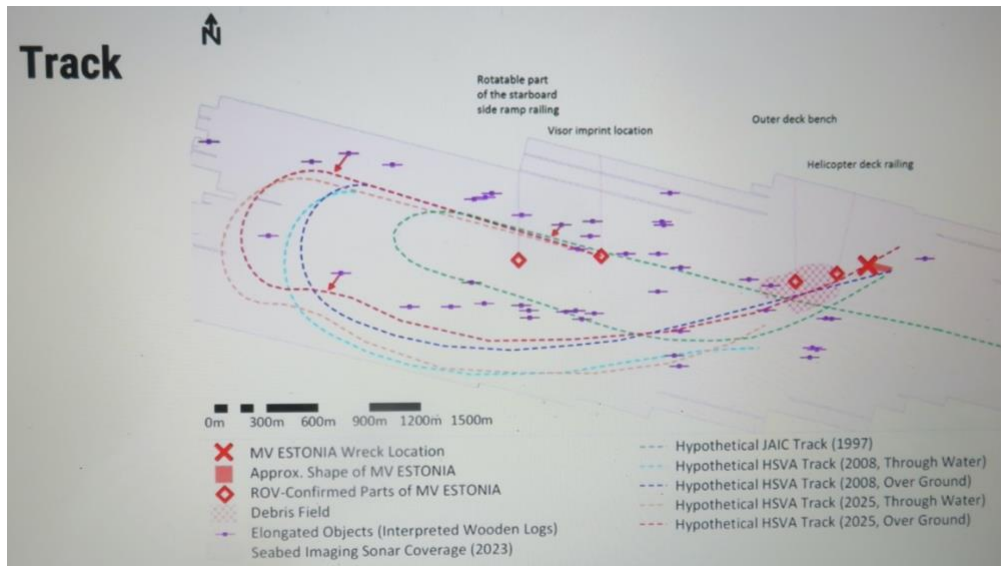
FIG. 4.4: Proposed tracks during the flooding and sinking of MV ESTONIA by JAIC, Valanto, and Kim et al.[1], [2], [3] The main reference points of the vessel's track reconstructions are shown.
